Overview of the 1st Quarter 2008 Surveillance and Maintenance Report for the DOE LM Rocky Flats Site

Rocky Flats Stewardship Council
August 4, 2008

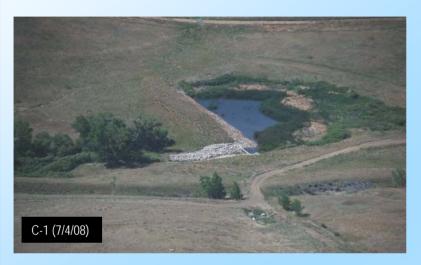
C-1 prior to breach (9/12/02)

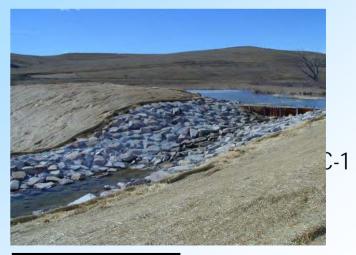
C-1 breach (2/21/05)

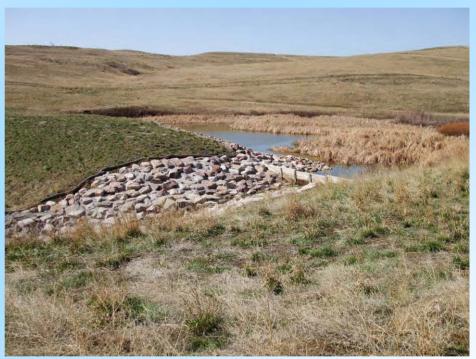
Breach at Dam C-1

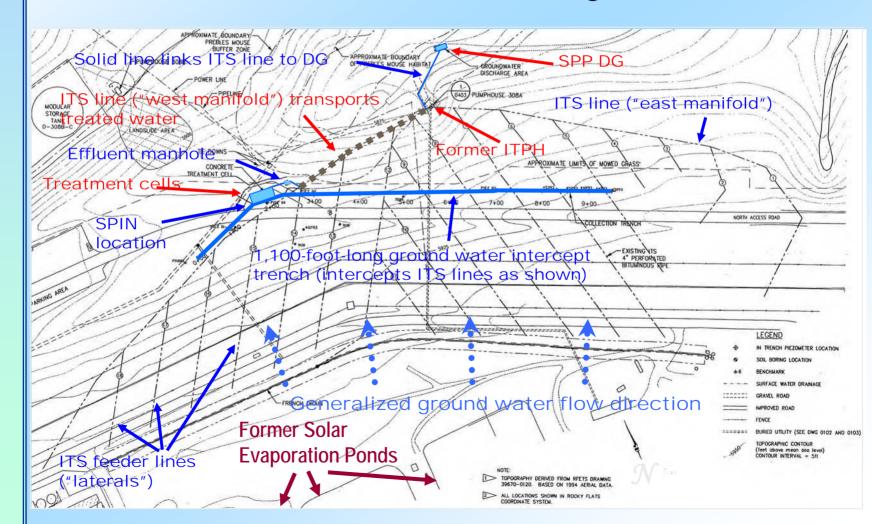
- Interceptor Trench System (ITS) remnants are present upgradient and downgradient of SPPTS groundwater intercept trench.
- Untreated groundwater at the Discharge Gallery (DG) is from ITS remnants, as confirmed through potholing investigation in spring 2007.

SPPTS and ITS current configuration

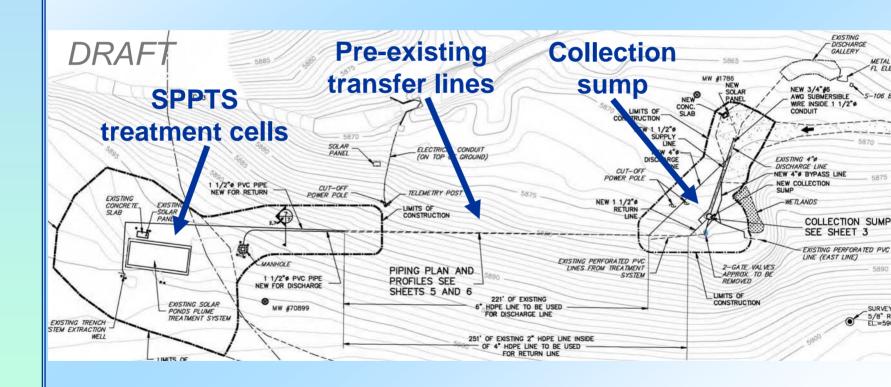
Draft drawing showing key Phase I features

- SPPTS Path Forward
 - SPPTS improvements will be performed in phases
 - Phase I: Install collection sump (begins in August)
 - Located where ITS lines converge (near former Interceptor Trench Pump House [ITPH])
 - Collects water that is transferred (via pre-existing line) to SPPTS for treatment
 - Discharge treated water via pre-existing, un-perforated line to DG
 - Data collected following Phase I will define and inform any additional phases.

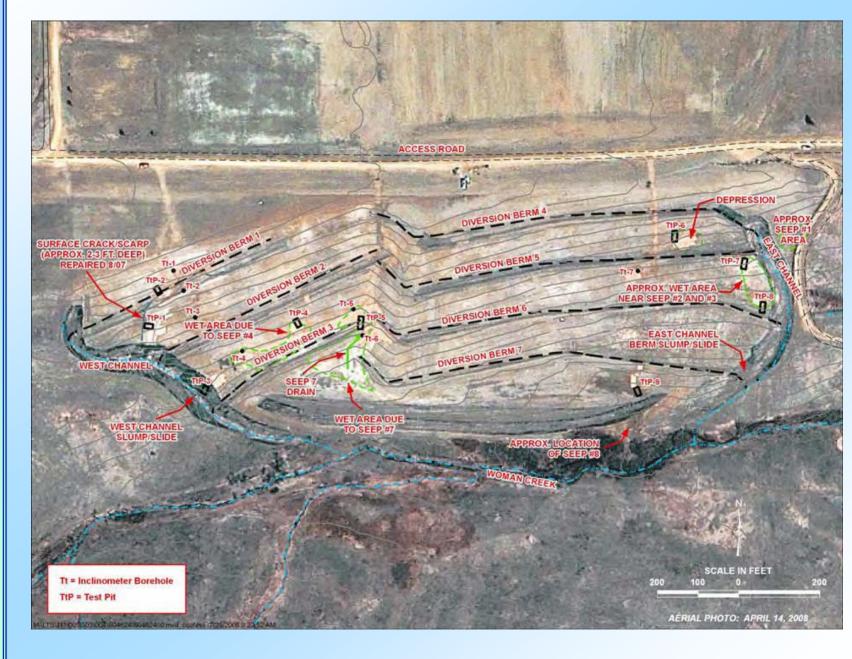
- 8 test pits ~ 20' long x 11-13' deep
 - Ninth test pit ~ 3'deep (to buttress drain depth)
- 7 boreholes ~ 28-39' deep (into bedrock)
 - Continuous core samples
 - Inclinometers to accurately measure movement
- Clay layer with organic materials appears to be a weak interface area
 - Percolating moisture lubricates
 - Modeling predicts small-scale instability
- Buttress performing as modeled
 - No large-scale OLF instability

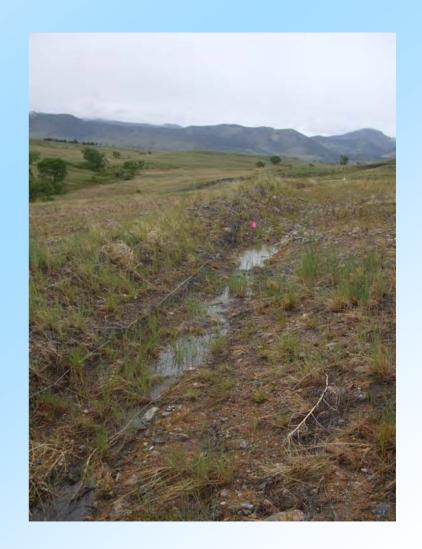
- High and low spots in channel allow minor ponding in low-flow condition.
- Heights below 2 feet due to minor settlement and localized slumping.
 - High-flow (24 hour/100 year and 1,000 year event model) condition would overtop the berms.

- Repair localized slumping/differential settlement by filling/grading.
 - Area below Berm #1 repaired last summer with good results.
- Fill/regrade perimeter channel to reduce slope and improve stability at berm ends, as needed.
- Two-foot berm height difficult adjust height along length based on sub-basin model.
- Conduct routine maintenance for observed ponding in berm channels - regrade high and low spots.
- Install extension to Seep #7 drain to direct water to buttress drain.
